**LEE LAKE AQUATIC VEGETATION  
SURVEY & MANAGEMENT RECOMMENDATIONS REPORT**

**A SURVEY OF  
AQUATIC VEGETATION IN  
LEE LAKE  
CALHOUN COUNTY, MICHIGAN**

**AUGUST, 2013**

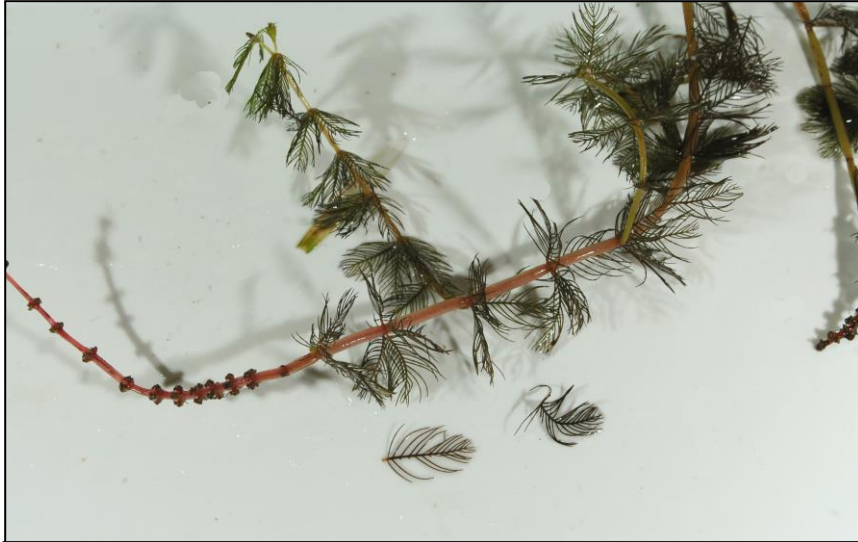
Figure 1. Eurasian Watermilfoil with seed head and lateral branches.  
©Restorative Lake Sciences, LLC

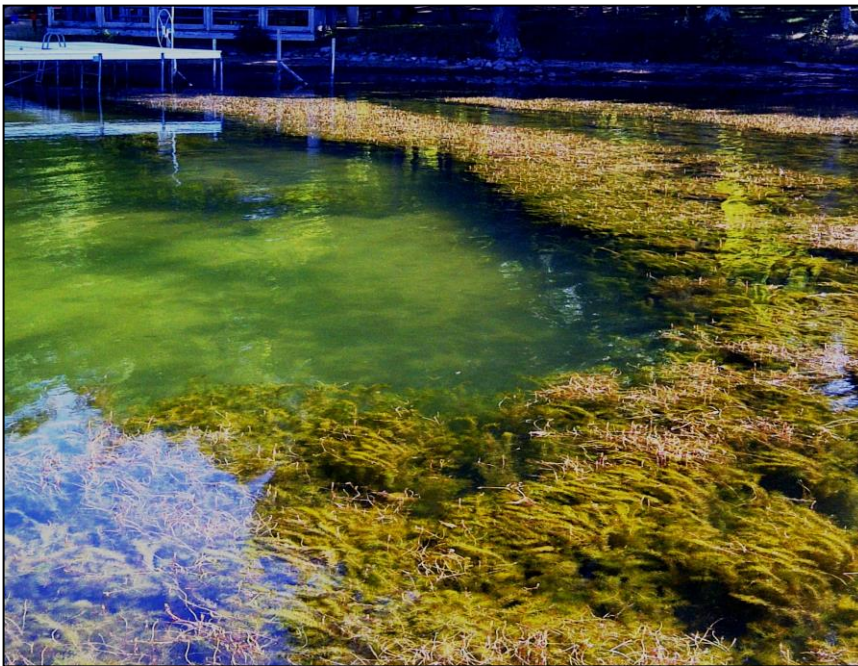
Figure 2. Growth habit of hybrid watermilfoil showing rigorous canopy.  
©Restorative Lake Sciences, LLC

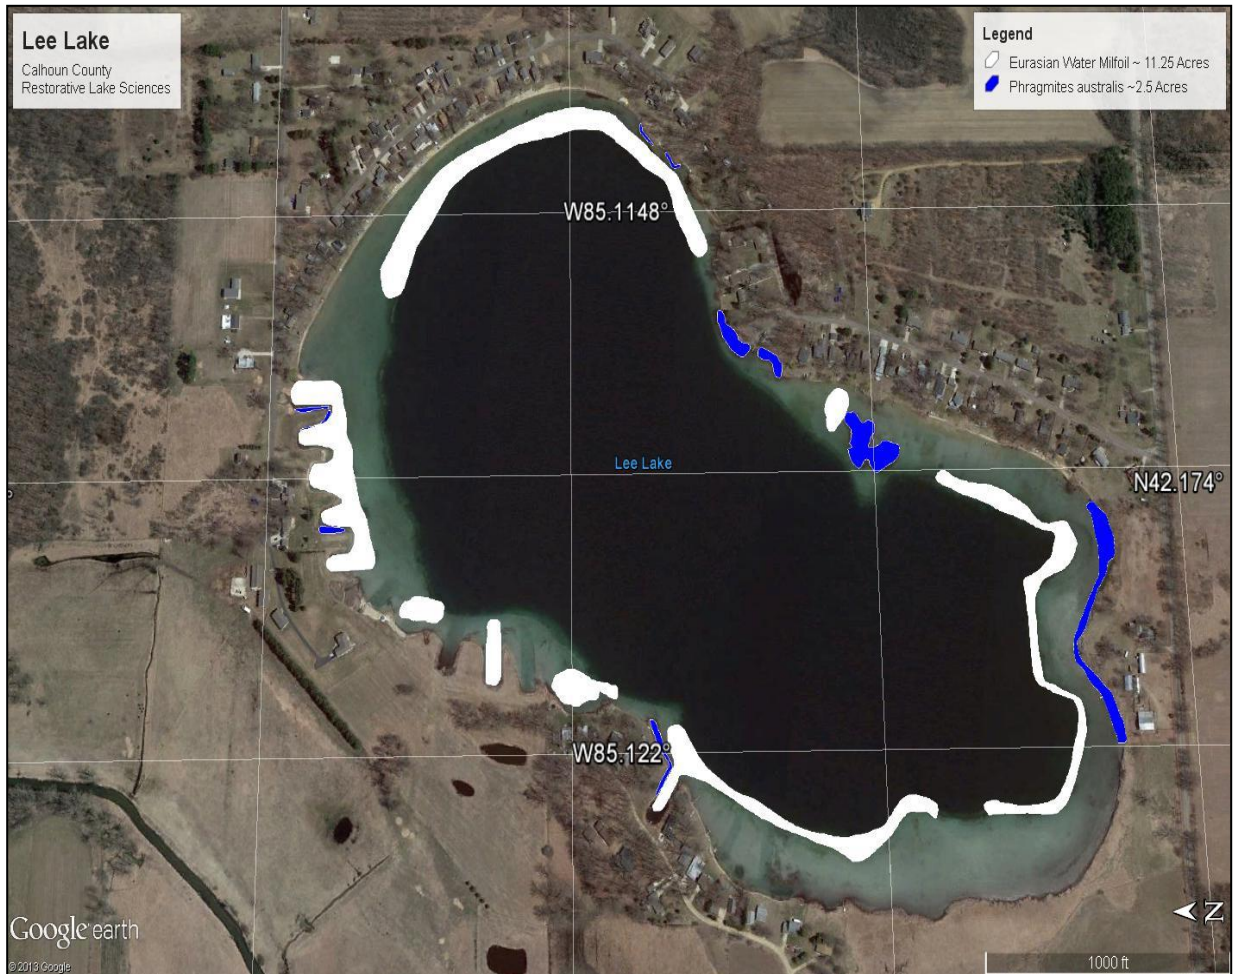
Approximately 23% of the shallow (littoral) zone area of Lee Lake contained Hybrid Watermilfoil at the time of the survey. In addition, approximately 12% of the shoreline contained *Phragmites* and 0.3% of the shoreline was occupied by Purple Loosestrife. This is approximately 11.3 acres of milfoil distributed within Lee Lake. The distribution of Hybrid Watermilfoil was widely scattered around the lake (Figure 3) and is denoted by white polygons.

Figure 3. Distribution of Hybrid Watermilfoil and Phragmites in and around Lee Lake (August, 2013).

**The preferred management method for the milfoil problem is to conduct a rigorous 12-acre systemic aquatic herbicide treatment in the spring or early summer of 2014 and then spot-treat with herbicides as needed in subsequent years. Additionally, the use of herbicides such as Imazapyr, Imazamox, and Glyphosate are used for chemical control of *Phragmites*. A proposed program with associated costs is shown below in Table 4.**

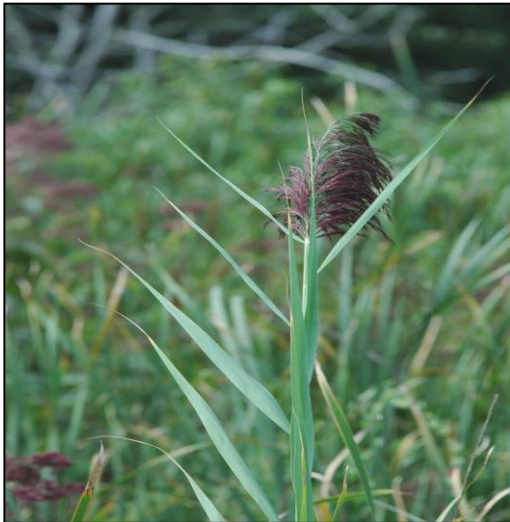
**In addition to the exotic Hybrid Watermilfoil, stands of the exotic emergent Giant Common Reed (*Phragmites australis*; Figure 4) was found around the shoreline.** *Phragmites* is an imminent threat to the surface area of Lee Lake since it may grow submersed in water depths of 2 or more meters (Herrick and Wolf, 2005), thereby drying up wetland habitat and reducing lake surface area. In addition, large, dense stands of *Phragmites* accumulate sediments, reduce habitat variability, and impede natural water flow (Wang et al., 2006). Thus, it is imperative to control *Phragmites* in the tributary areas as well in an effort to preserve the natural hydrology of the Lee Lake ecosystem.

Figure 4. Phragmites  
© Restorative Lake Sciences, LLC

**The treatment of Phragmites can be conducted either with hand-swiping of the seed plumes with herbicides such as Glyphosate or with hand removal of the seed heads and removal of the underground runners that create new plants.**

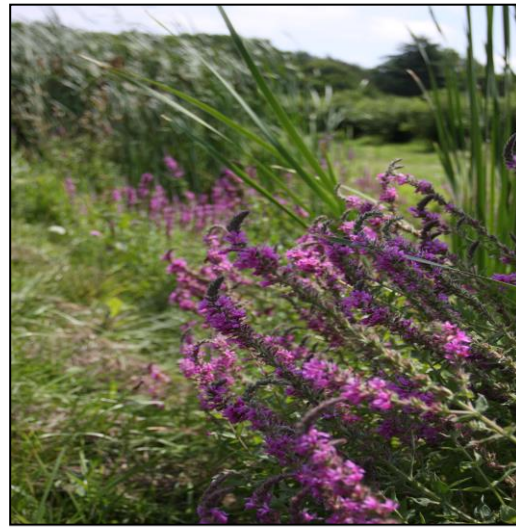
**The exotic emergent plant, Purple Loosestrife (*Lythrum salicaria*; Figure 5) was also found** around some shoreline areas (at the northernmost region, the easternmost region, and the south shore) and should also be managed. Purple loosestrife is an invasive (i.e. exotic) emergent aquatic plant that inhabits wetlands and shoreline areas. It has showy magenta-colored flowers that bloom in mid-July and terminate in late September. The seeds are highly resistant to tough environmental conditions and may reside in the ground for extended periods of time. It exhibits rigorous growth and may out-compete other favorable native emergents such as cattails (*Typha latifolia*) or native swamp loosestrife (*Decodon verticillatus*) and thus reduce the biological diversity of localized ecosystems. The plant is spreading rapidly across the United States and is converting diverse wetland habitats to monocultures with substantially lower biological diversity. Management options for the plant are provided in the management recommendations section of the report.

Figure 5. Purple Loosestrife  
© Restorative Lake Sciences, LLC

In addition, biological control vectors such as the beetles *Galerucella californiensis* and *G. pusilla* (Figure 25) have been effective on the treatment of shoreline Purple Loosestrife in many locations throughout the Midwest. However, these beetles usually prefer a large stand of purple loosestrife to promote their population. Individual plants or small colonies are better controlled by pulling individual plants out of the soil with a shovel and discarding the plants in a sealed garbage bag. Large stands of Purple Loosestrife may be treated with the land application form of Triclopyr.

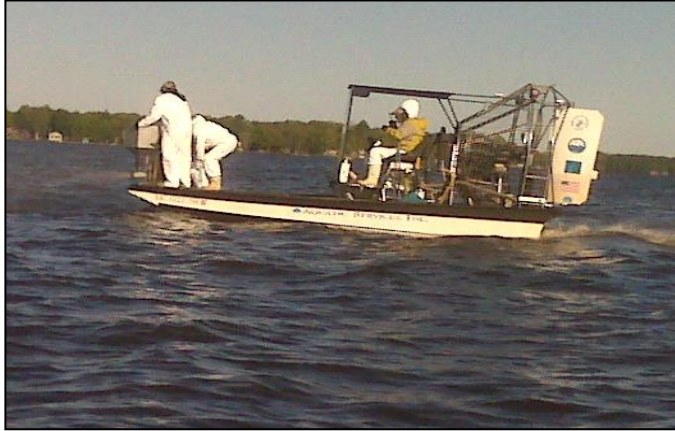
Algae treatments through the use of algaecides should be limited to filamentous algal blooms and efforts should be taken to reduce the nutrient loads that encourage algal blooms that may require treatments. **The current low abundance of green algae in the water of Lee Lake denotes that algal treatments are not needed.** All products are applied to the lake in a specialized treatment boat similar to the one in Figure 21.

Figure 21. An airboat used to apply aquatic herbicides.

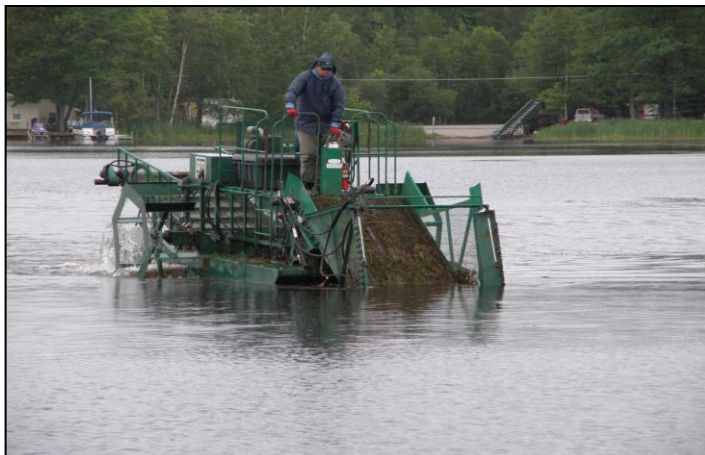
Mechanical harvesting involves the physical removal of nuisance aquatic vegetation with the use of a mechanical harvesting machine (Figure 22). The mechanical harvester collects numerous loads of aquatic plants as they are cut near the lake bottom. The plants are off-loaded onto a conveyor and then into a dump truck. Harvested plants are then taken to an offsite landfill or farm where they can be used as fertilizer. Mechanical harvesting is preferred over chemical herbicides when primarily native aquatic plants exist, or when excessive amounts of plant biomass need to be removed. Mechanical harvesting is usually not recommended for the removal of Eurasian Watermilfoil since the plant may fragment when cut and re-grow on the lake bottom. **Due to the threat of milfoil fragmentation, the use of mechanical harvesting for the removal of the milfoil in Lee Lake is not recommended.**

Figure 22. A mechanical harvester.

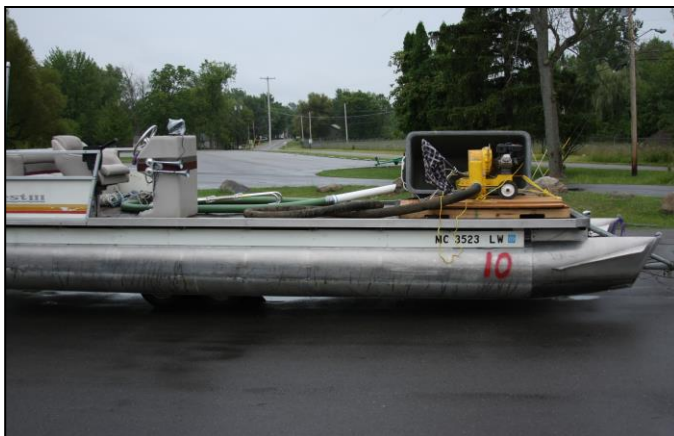
Suction harvesting via a Diver Assisted Suction Harvesting (DASH) boat (Figure 23) involves hand removal of individual plants by a SCUBA diver in selected areas of lake bottom with the use of a hand-operated suction hose. Samples are dewatered on land or removed via fabric bags to an offsite location. **This method is generally recommended for small (less than 1 acre) spot removal of vegetation since it is costly on a large scale. It may be used in the future to remove small remaining areas of milfoil after large-scale initial treatments have reduced milfoil beds to manageable levels.**

Figure 23. A DASH boat for hand-removal of milfoil or other nuisance vegetation. ©Restorative Lake Sciences, LLC

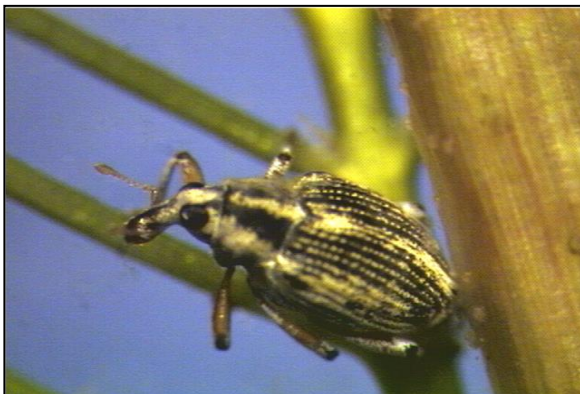
The use of the aquatic weevil, *Euhrychiopsis lecontei* (Figure 24) to control Eurasian Watermilfoil has been implemented in a few lakes in Michigan. The use of the weevil for bio-control is both inundative and classical (Harley and Forno, 1992). The inundative approach refers to the application of weevils at a higher density than the existing population to damage milfoil. The classical approach refers to the use of a host-specific herbivore (weevil) to damage the target plant (milfoil). The weevil naturally exists in many of our lakes; however, the lack of adequate populations in many lakes requires that they be implanted or stocked for successful control of milfoil. The weevil feeds almost entirely on milfoil and

will leave native aquatic species unharmed if adequate amounts of milfoil are present. The weevil burrows into the stems of milfoil and damages the vascular tissue, thereby reducing the plant's ability to store carbohydrates (Newman et al. 1996). Eventually, the stems lose buoyancy and the plant decomposes on the lake bottom.

Figure 24. The milfoil weevil (*Euhrychiopsis lecontei*). Photo from R. Newman used with permission.

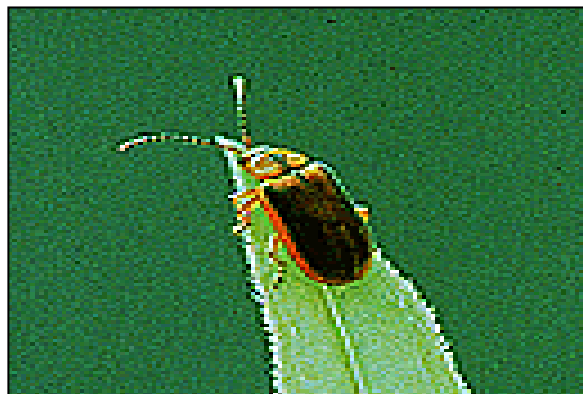
Figure 25. The Purple Loosestrife beetle (*Galerucella* sp.). Photo from USGS.

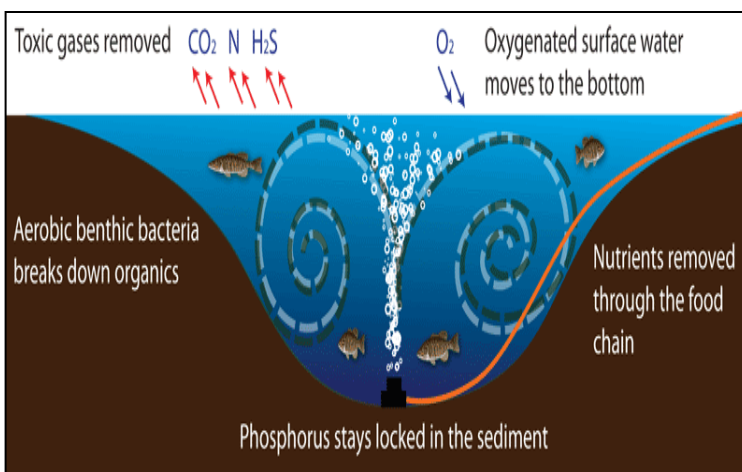
Laminar flow aeration systems (Figure 26) are retrofitted to a particular site and account for variables such as water depth and volume, contours, water flow rates, and thickness and composition of lake sediment. The systems are designed to completely mix the surrounding waters and evenly distribute dissolved oxygen throughout the lake sediments for efficient microbial utilization. A laminar flow aeration system utilizes diffusers which are powered by onshore air compressors. The diffusers are connected via extensive self-sinking airlines which help to purge the lake

Figure 26. A diagram showing the laminar flow aeration mechanisms. ©Restorative Lake Sciences, LLC

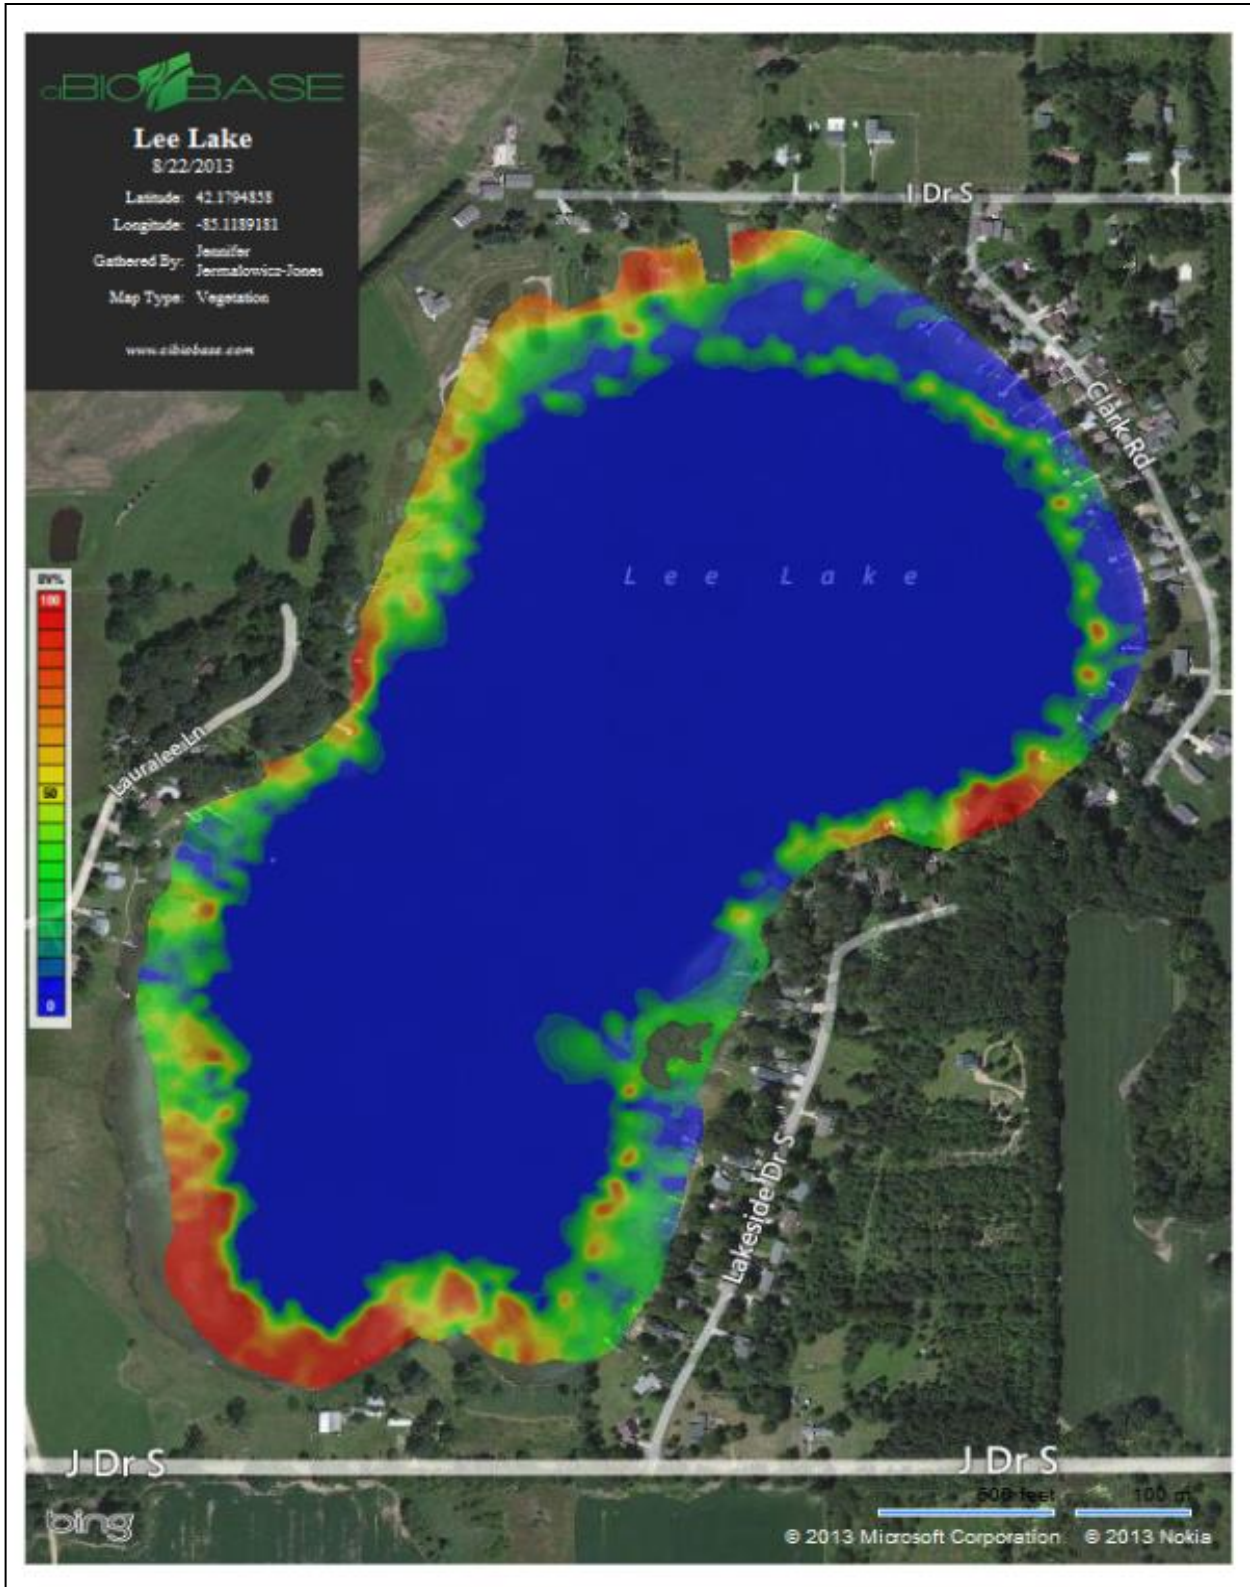
**APPENDIX A**

**BIOBASE SONAR SCAN MAP OF LEE LAKE SHALLOW WEED-INFESTED AREAS**

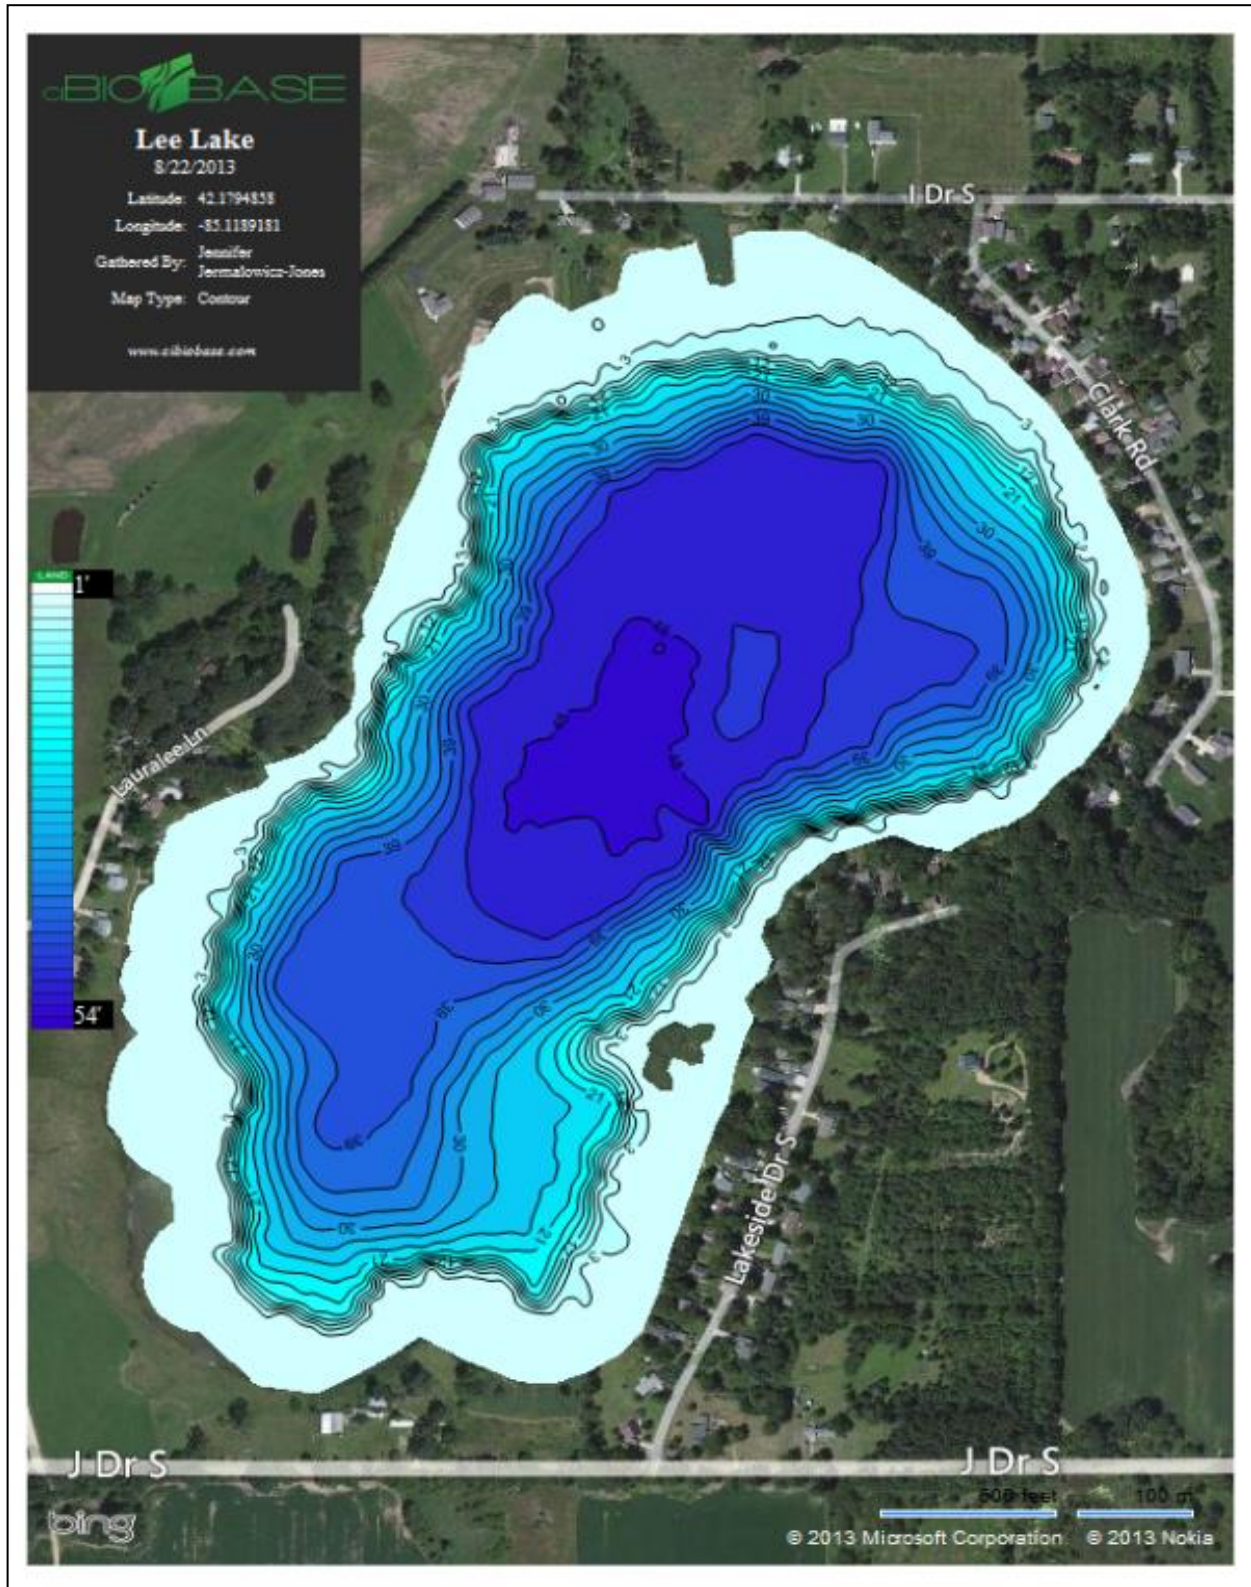
**APPENDIX B**

**BIOBASE SONAR SCAN MAP OF LEE LAKE DEPTH CONTOURS**
